## Fire Compartmentation

Issues and ad-hoc testing

## Gordon Rolfe

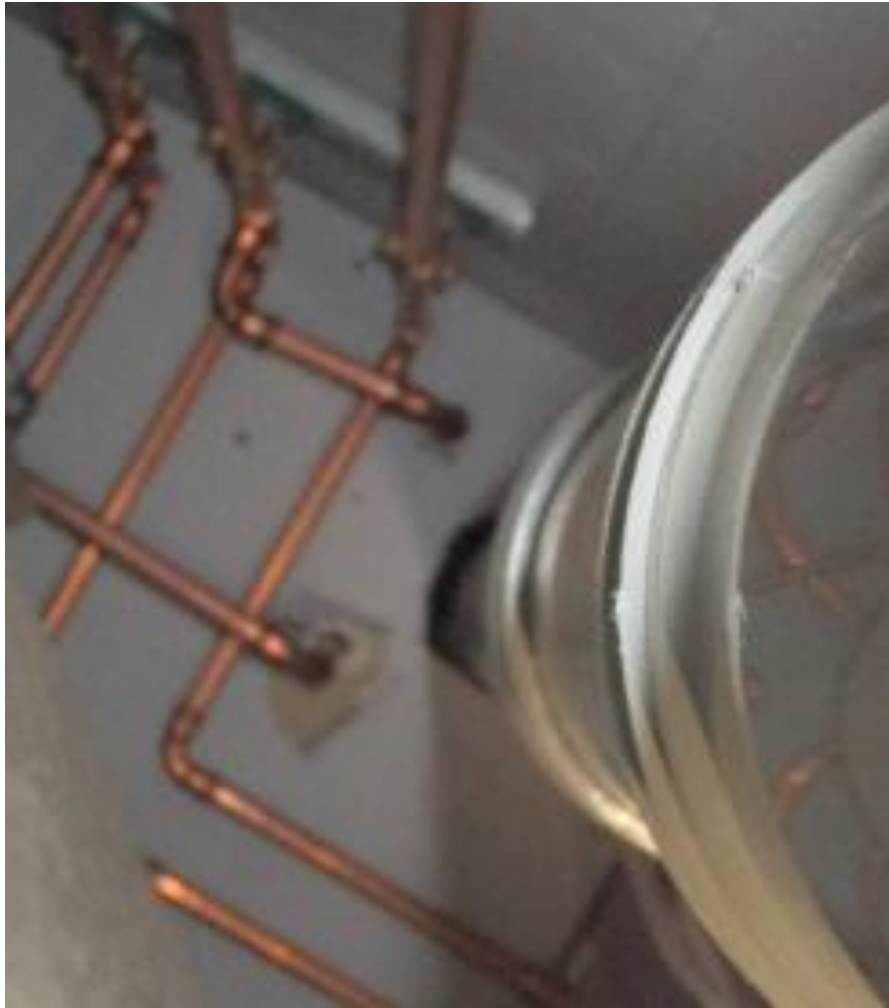
**Often in difficult to reach places,  
photograph taken from floor  
level access, around a pipe  
looking to ceiling and high wall  
breaches**

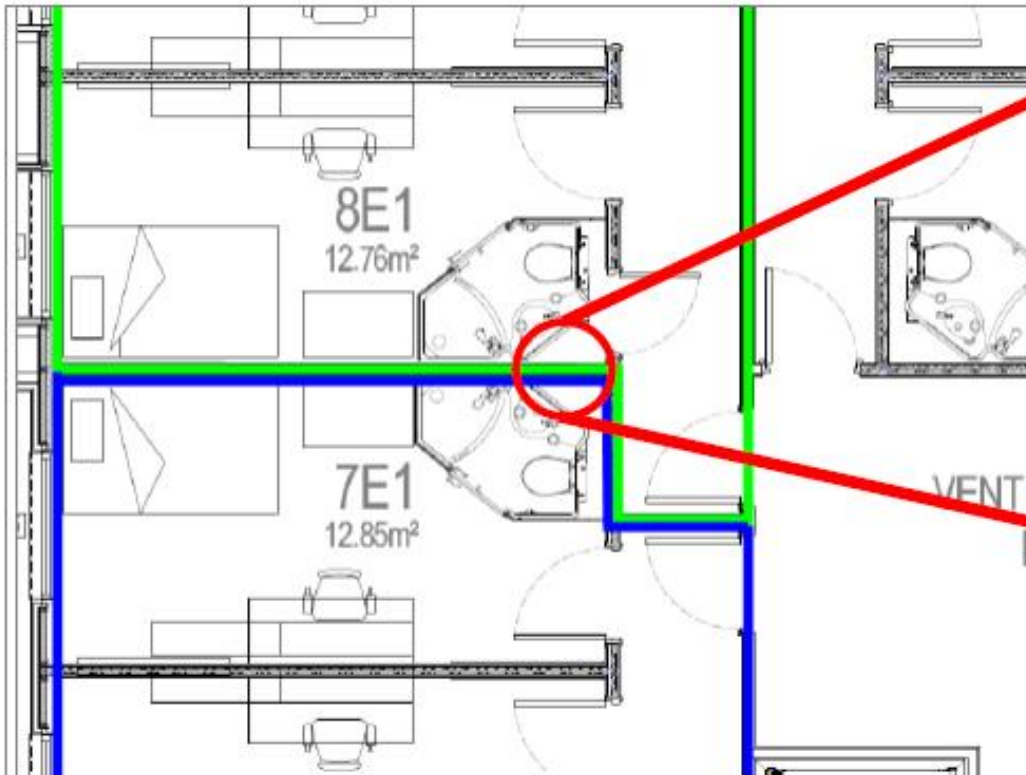
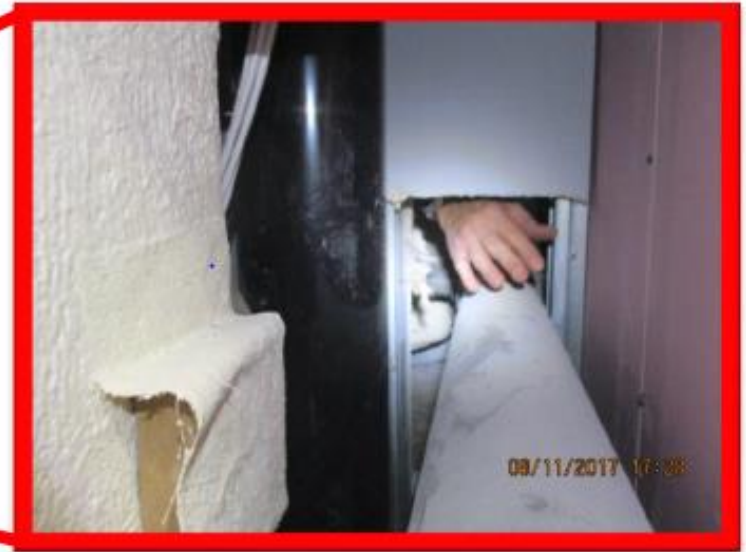
Other times the breaches are surprisingly easy to reach, in this case linking two compartments and two fire alarm zones

The hand is from a capita consultant located in the 8E cluster – The picture was taken from a 7E cluster. There are 2 breaches like this on each floor. These are:

- Between clusters 7 and 8
- Between clusters 4 and 5

In this example both vertical and horizontal compartment breaches were found throughout the building.

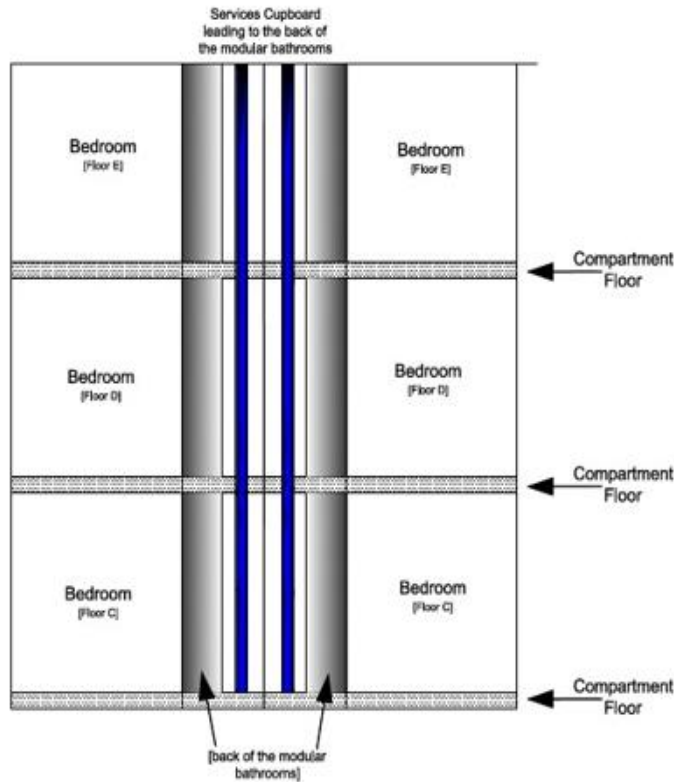
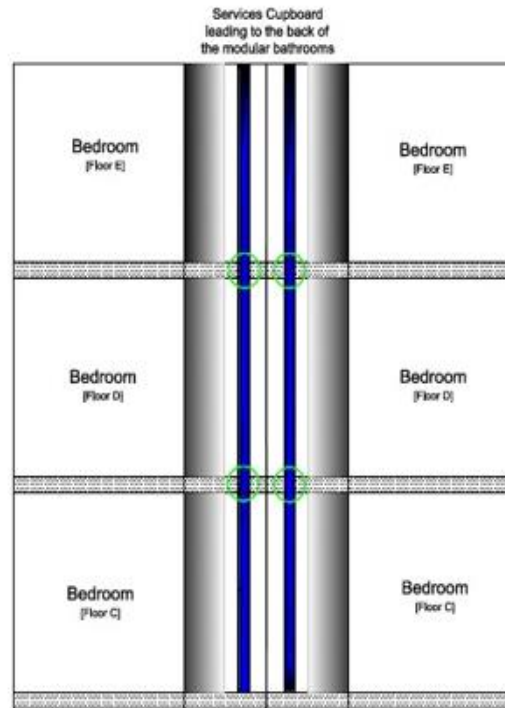
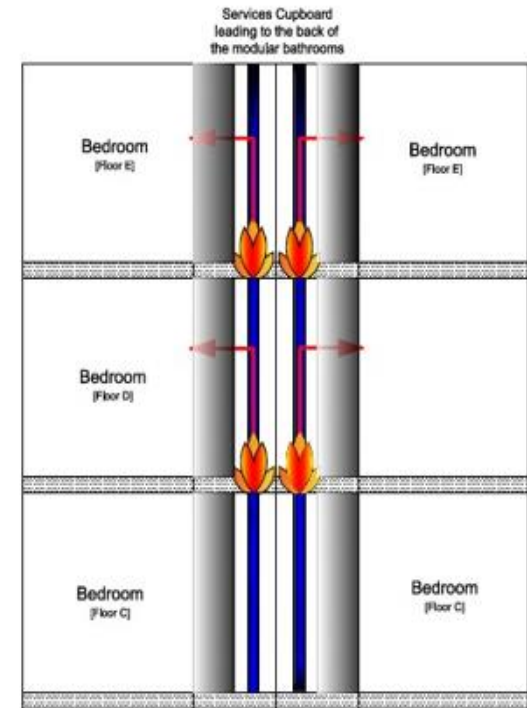
Incorrect fire stopped utility pipes breach the compartment floors. In a fire situation, this would allow fire to pass from floor to floor.

As fire breaches each floor, this would likely spread through the composite modular bathrooms in to the adjoining bedrooms due to the thermoplastic materials the bathrooms are constructed of.

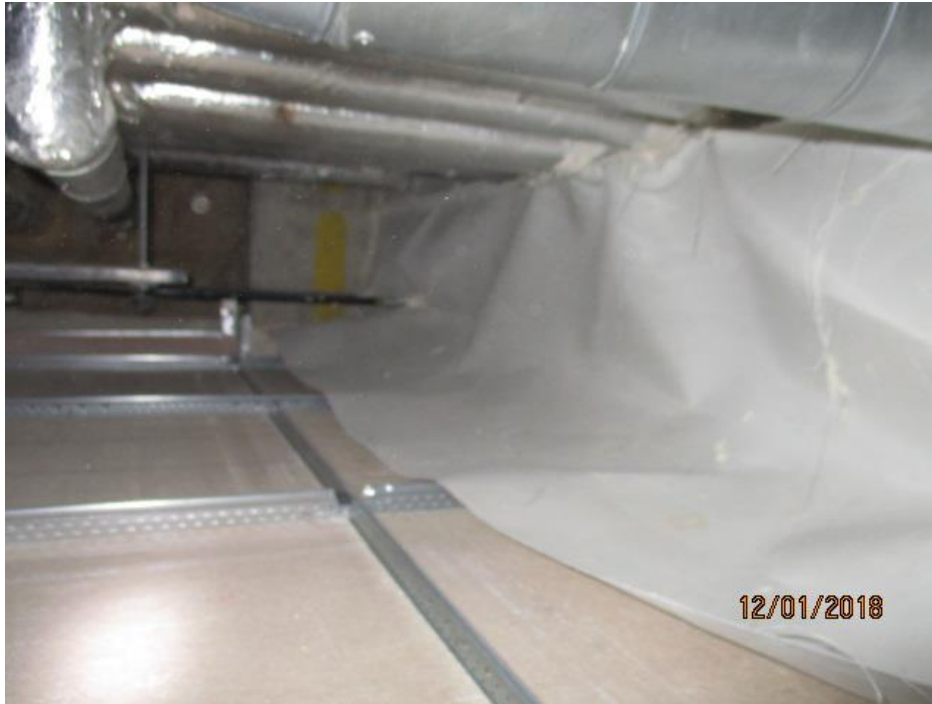
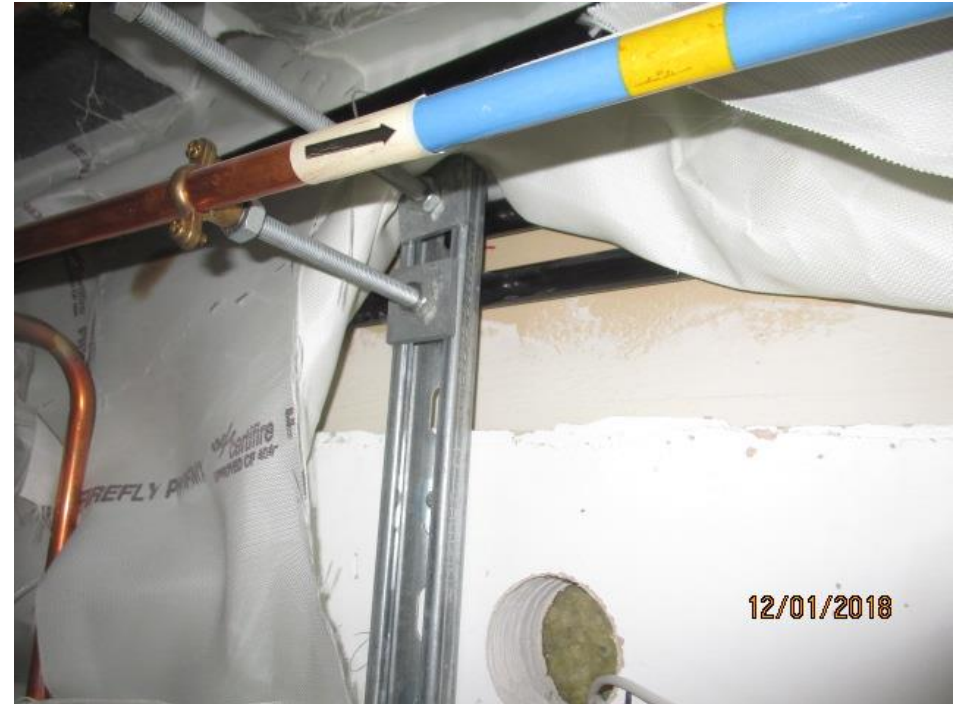
Fire curtains in loft/ roof or ceiling spaces are only effective if complete, gaps left by service engineers negate their effectiveness.

Fire curtains must be complete and with timber roofs extend to the first rafter.

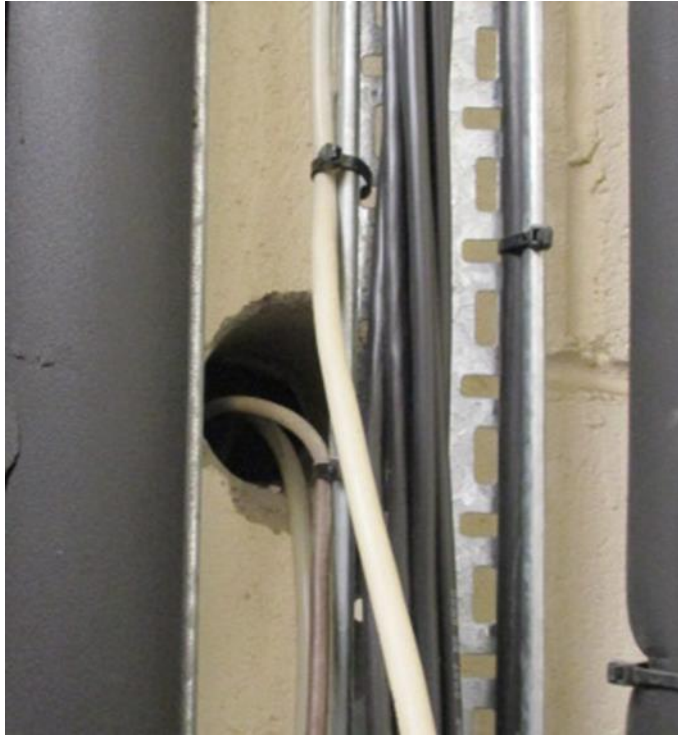
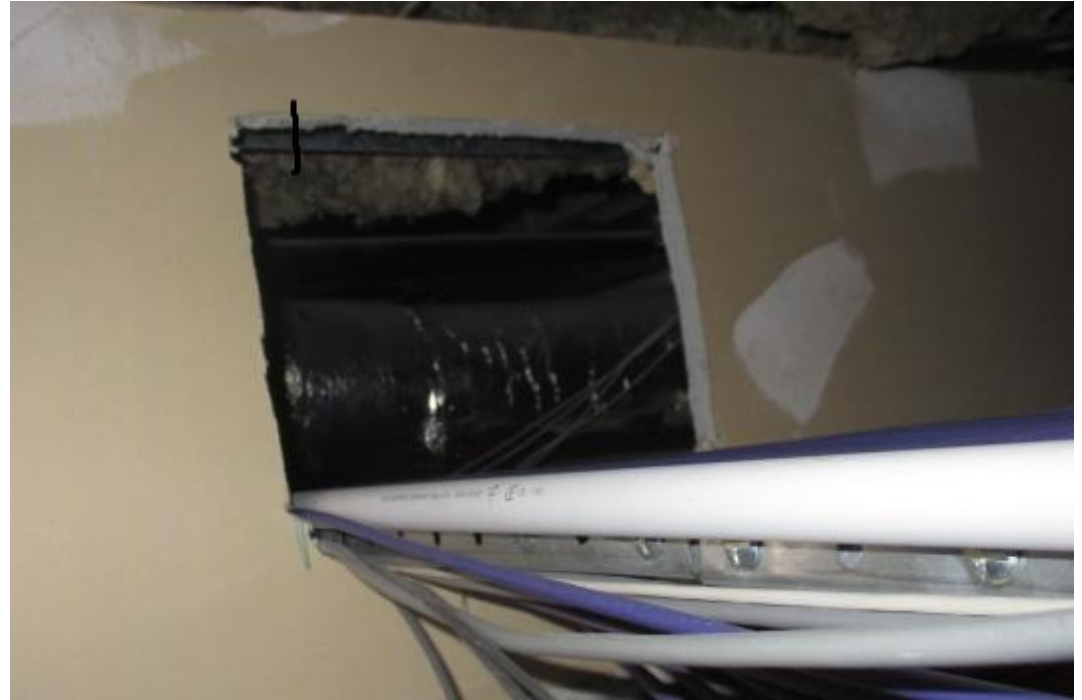
## Examples of over generously unstopped compartmentation holes

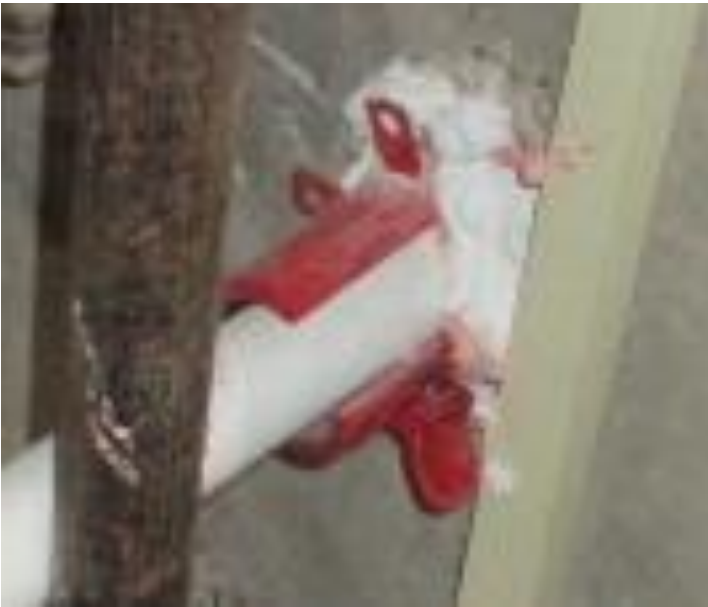
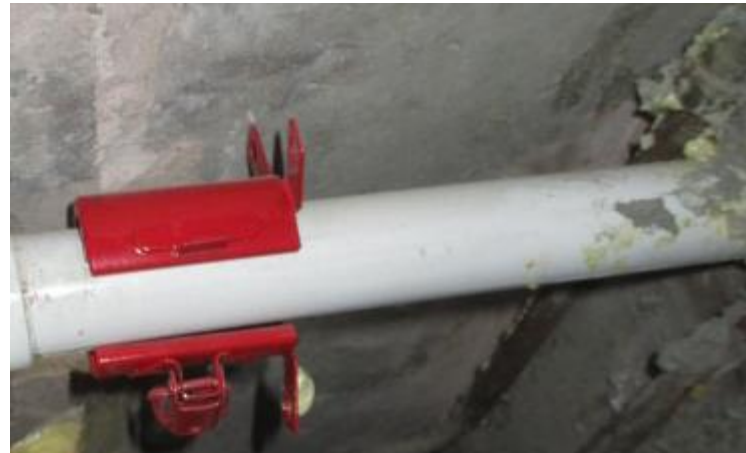
**It goes without saying that the intumescent material must be left in the clamp, stripped out on these two clamps as the pipe joint makes it impossible to wrap the metal clamp around the pipe**

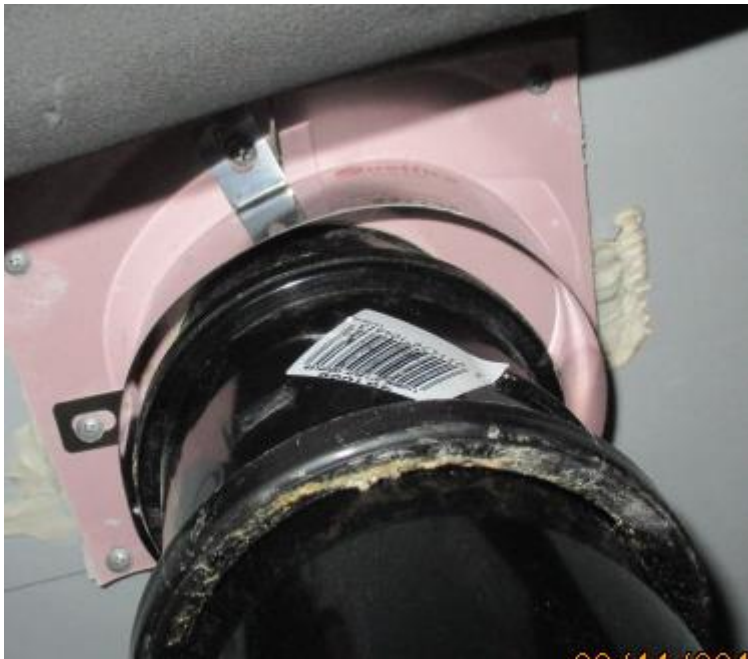
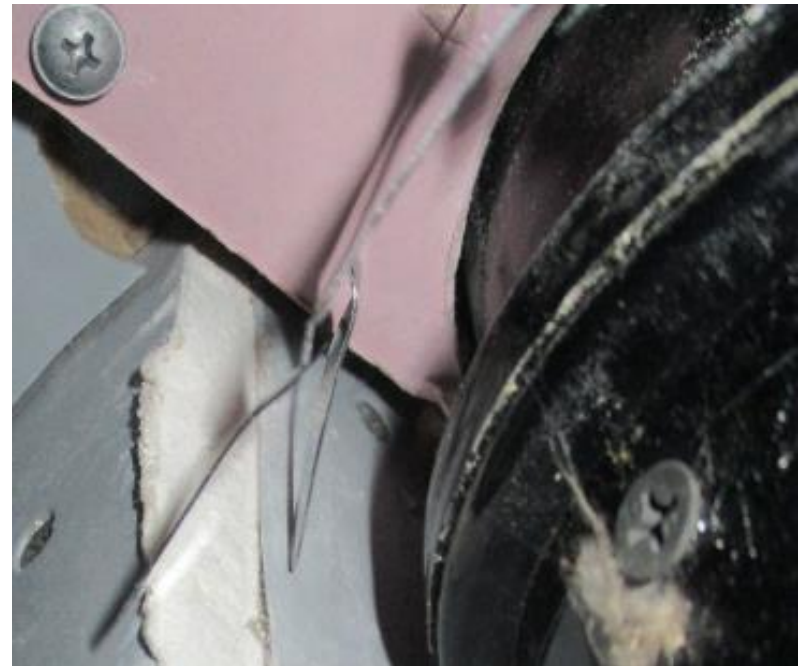
Wrapping two collars without securing them will just push the metal restraining rings away and not seal the pipe.

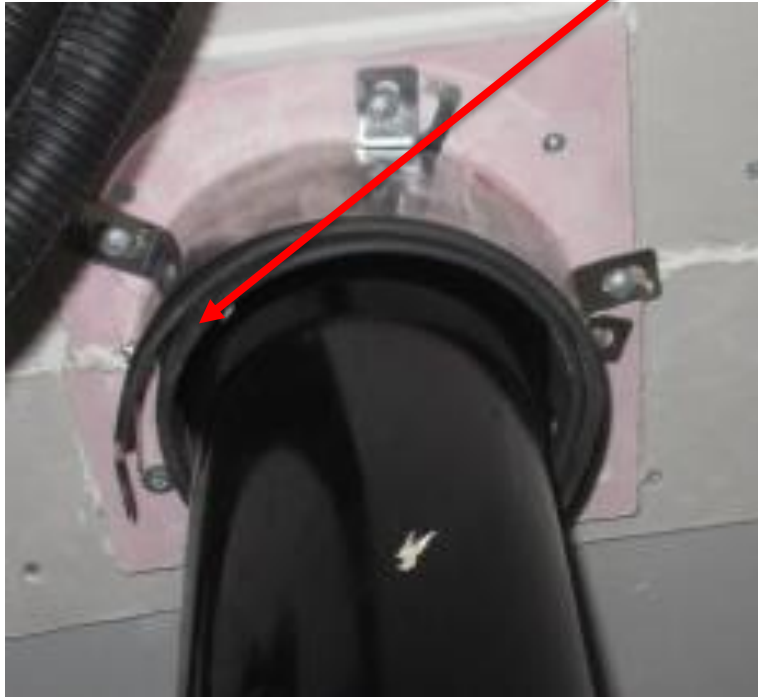
Leaving an opening in the plasterboard is a waste of everyone's time.

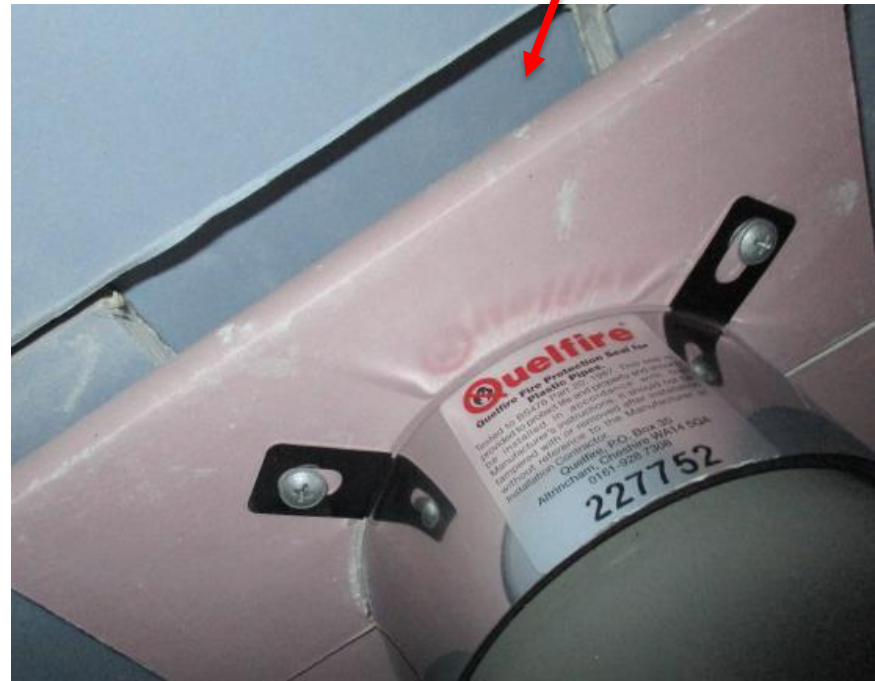
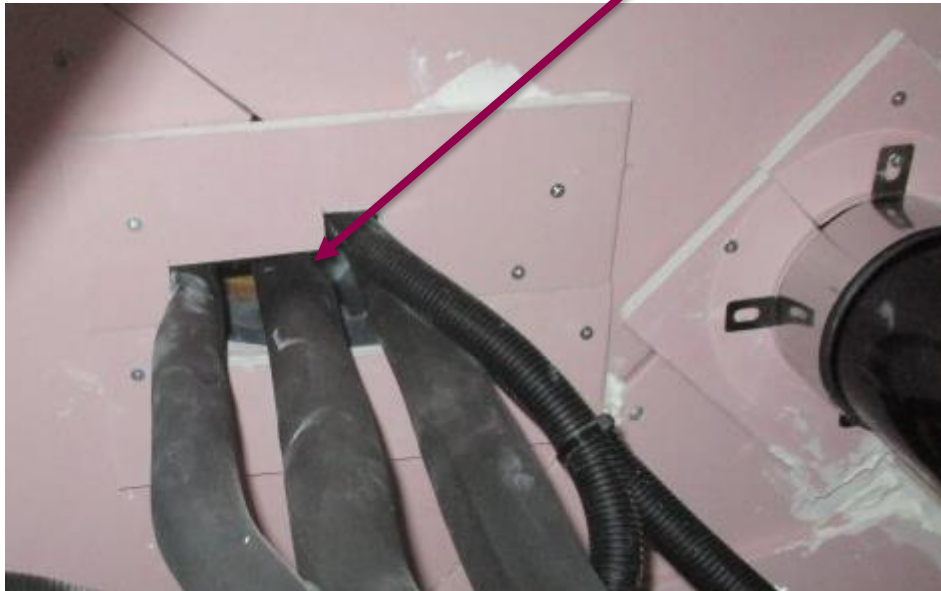
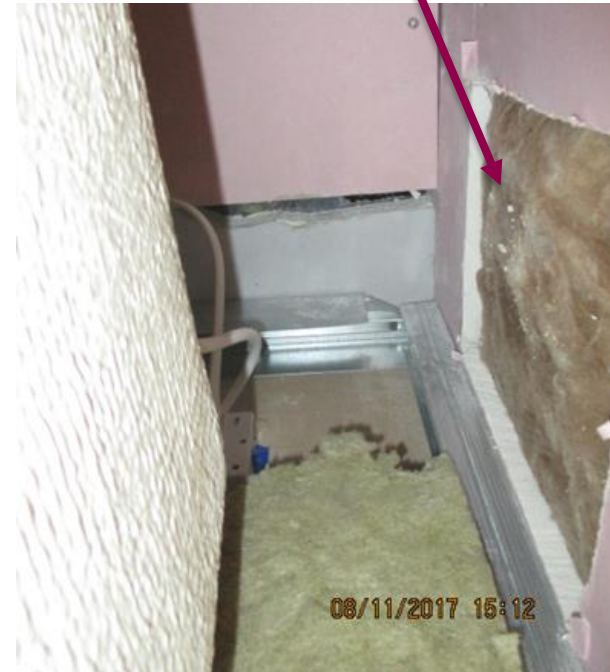
What is a good repair? It is not accepted practice to 'rob out' areas of compliant wall for plasterboard to repair holes in the ceiling.

At least back fill the pipes that you have attempted to make good

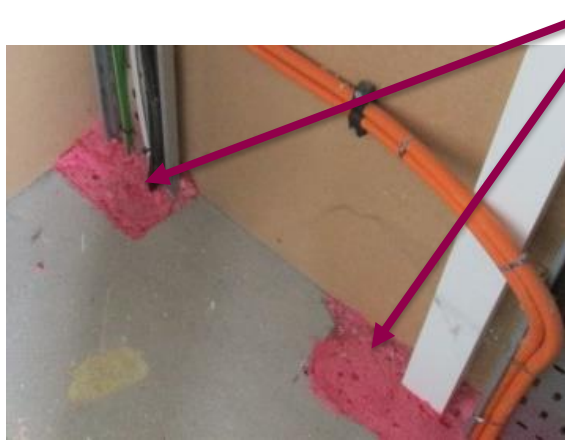
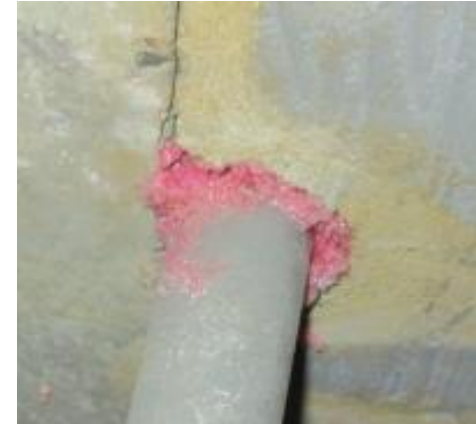
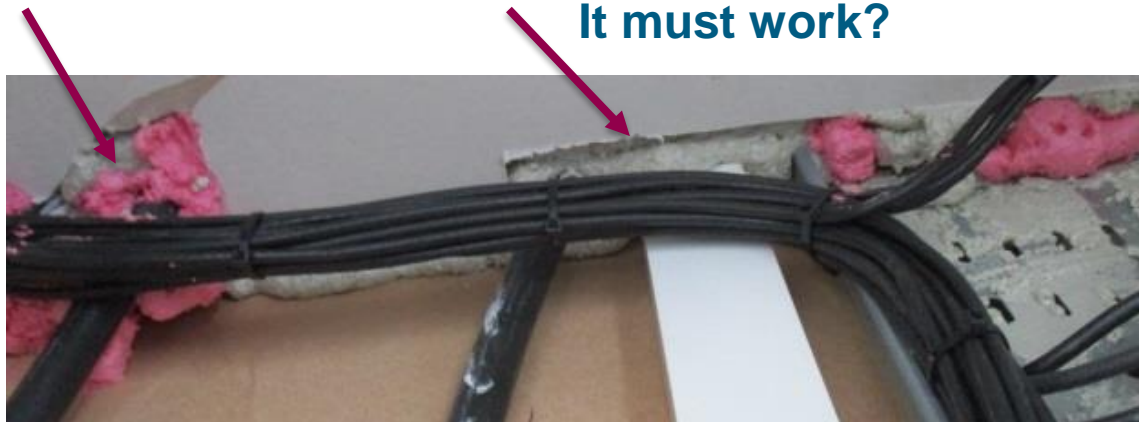
## Pink fire stopping foam from above

with 'pink' and none fire rated foam below.

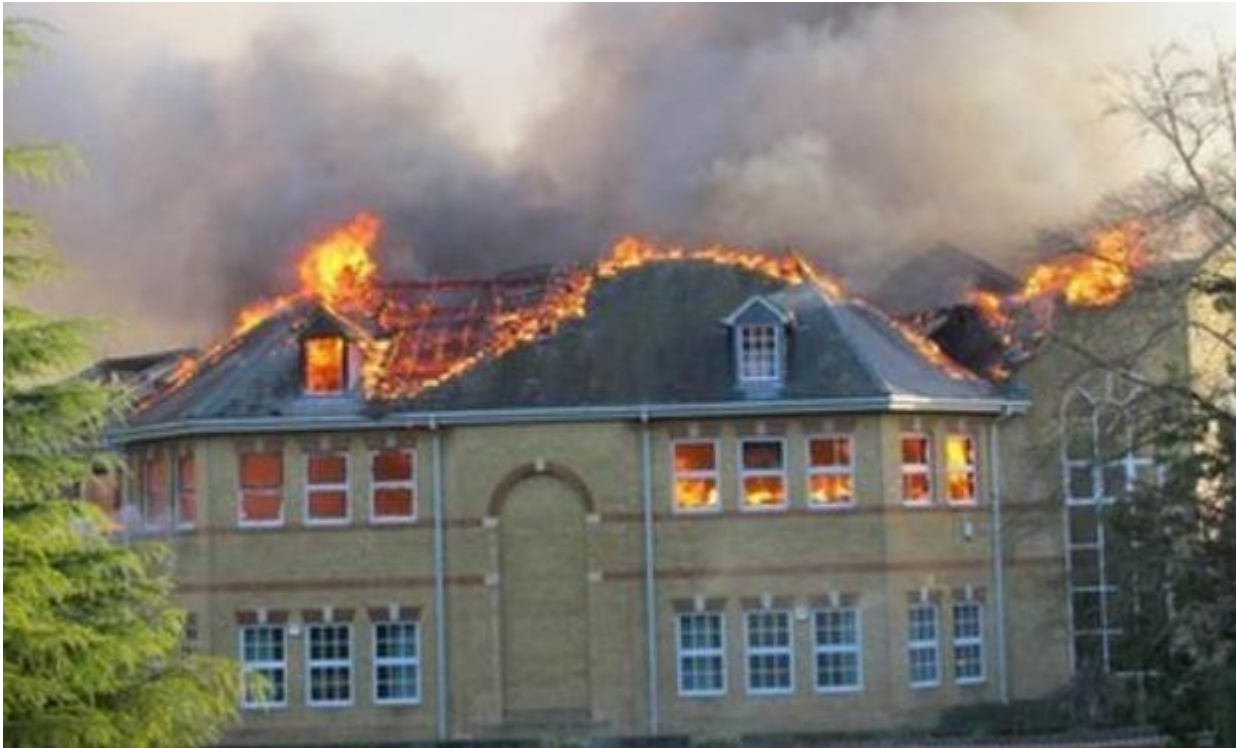
## A fire in a school (Dorset Area) with an un-compartmented roof void
