## Fire Compartmentation

Issues and ad-hoc testing

## Gordon Rolfe

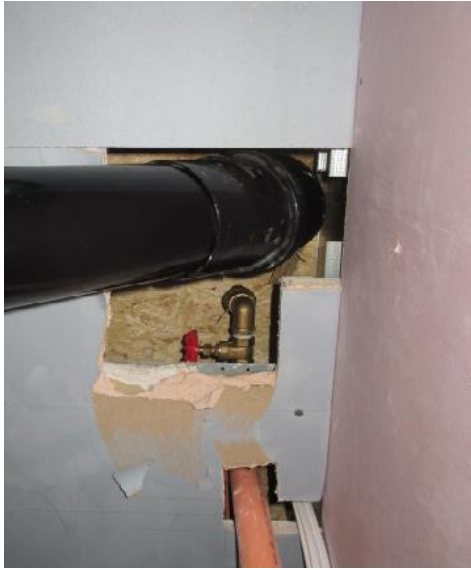
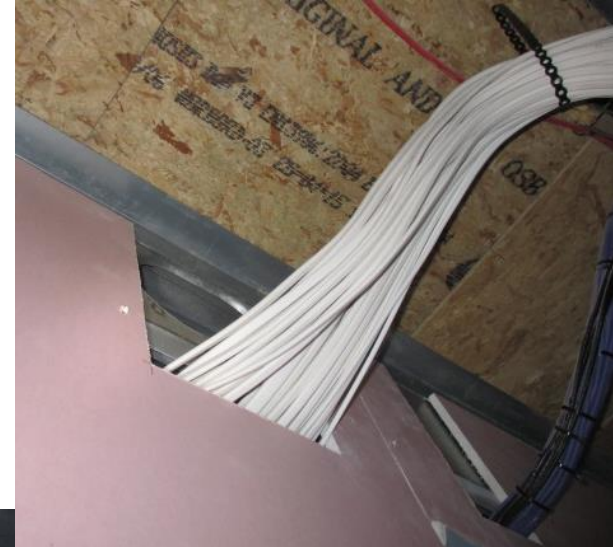
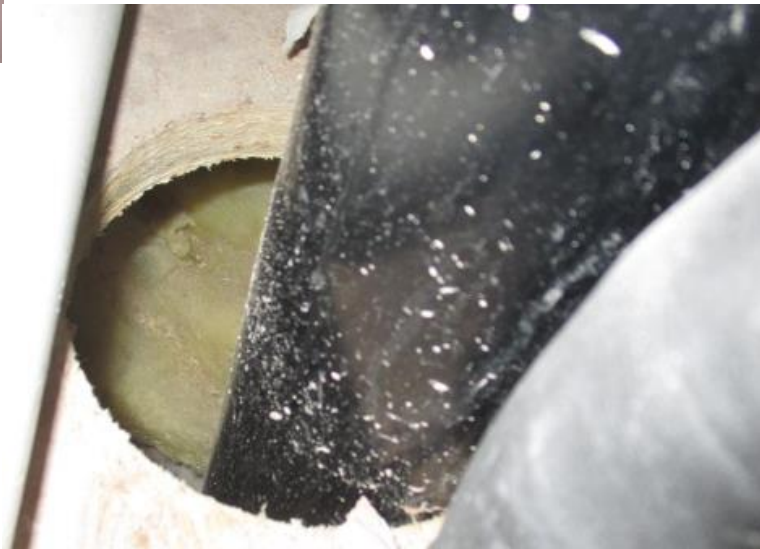
## How are issues identified ? Holes in the ceiling, the floor and the walls

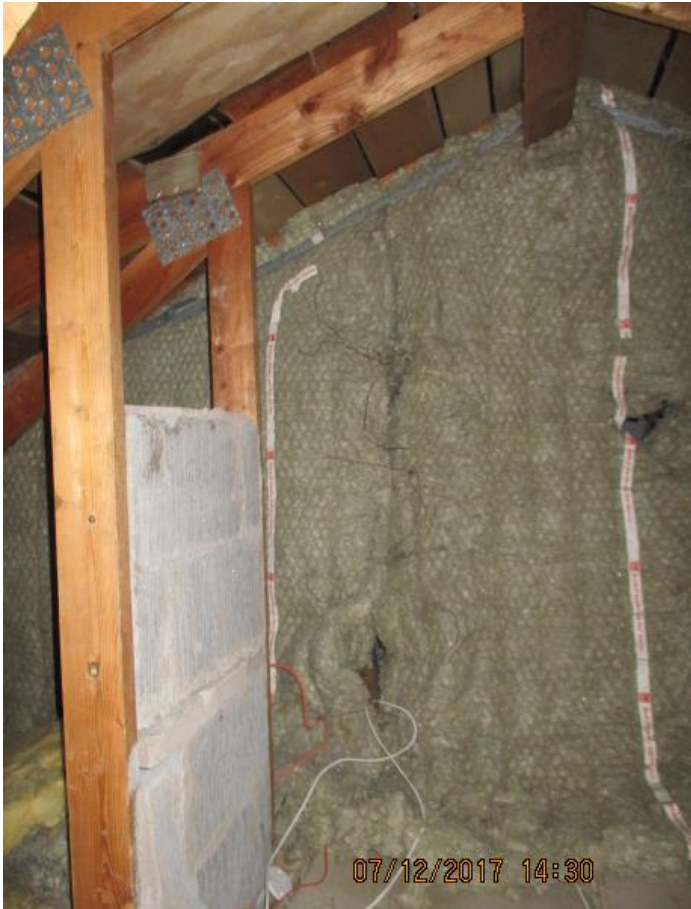
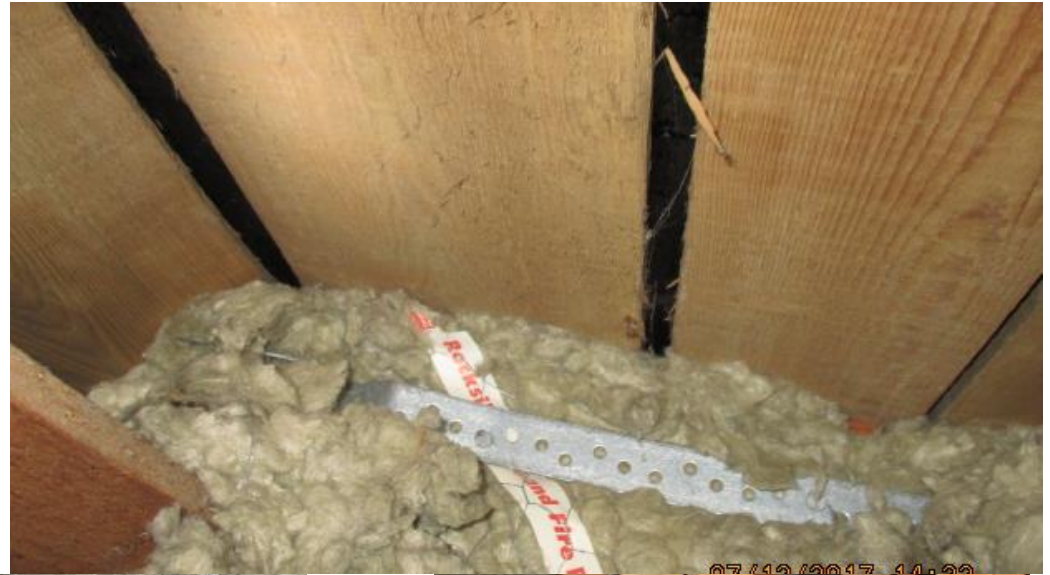
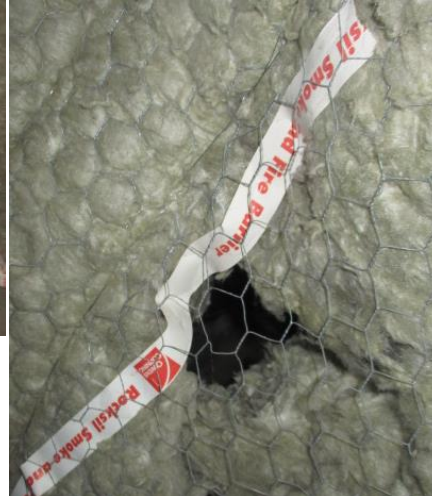
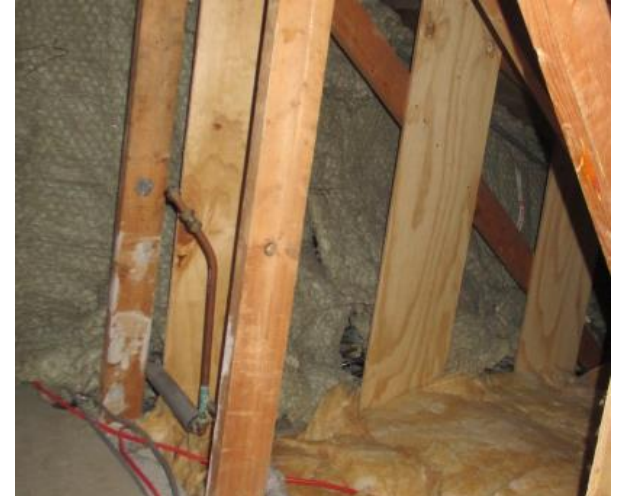
Fire curtains must be complete and with timber roofs extend to the first rafter.

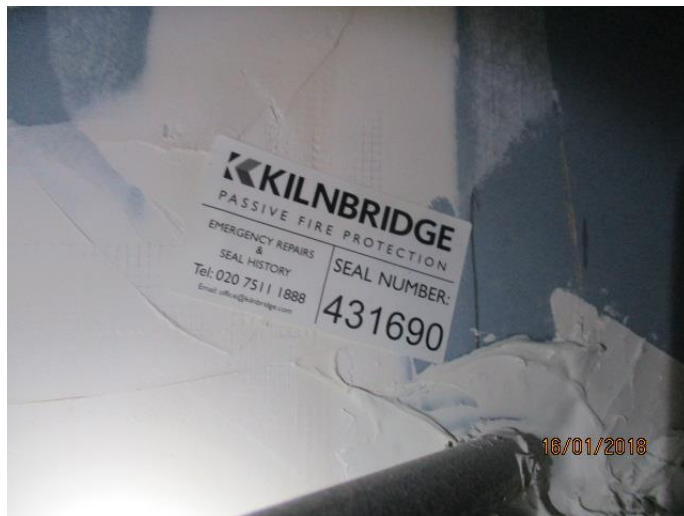
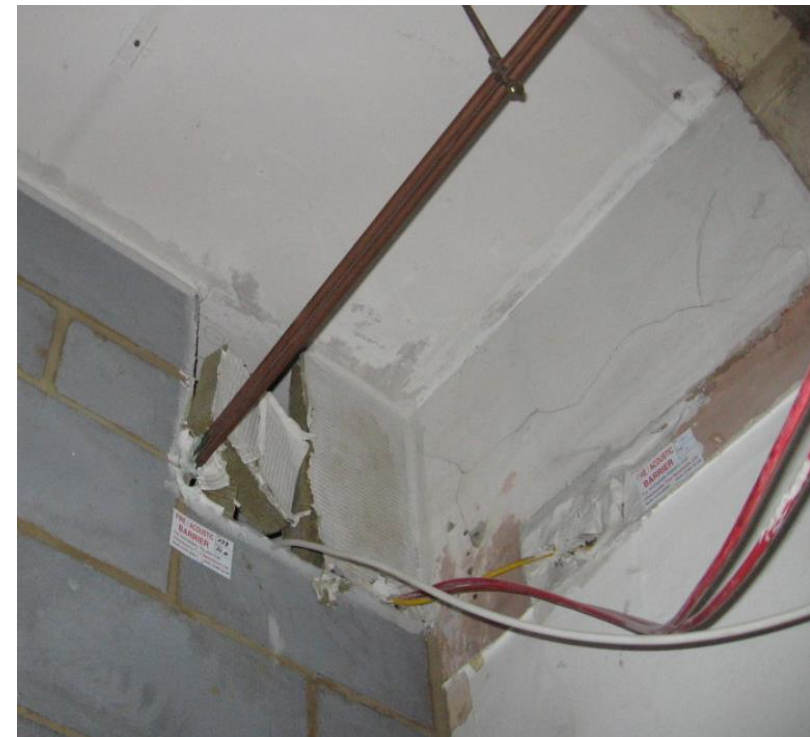
However there is no reliability that contractors will respect the compartmentation when fitting additional services.

Once installed the barrier should be identified with a 'who, when & how' Label.

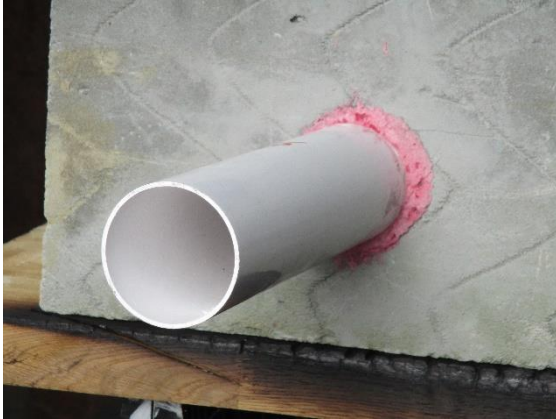
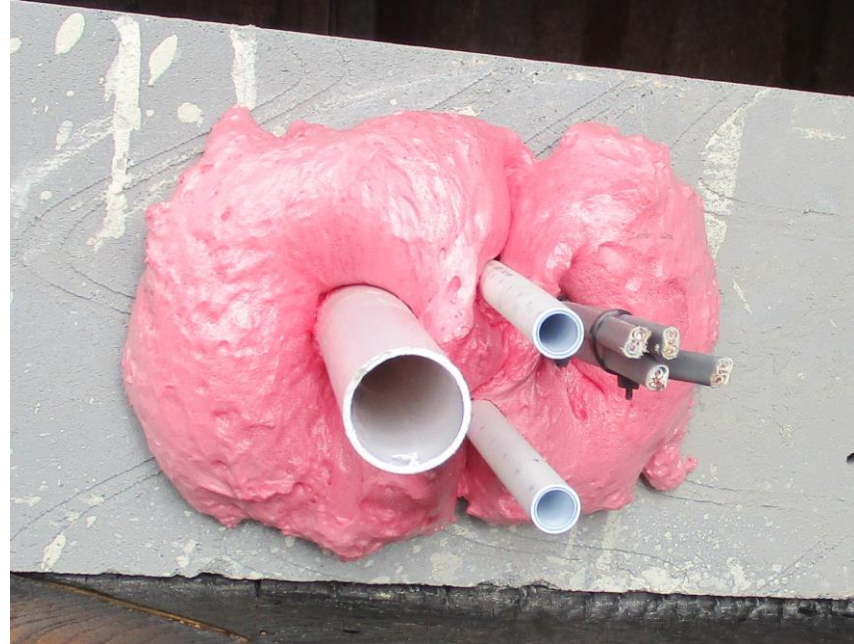
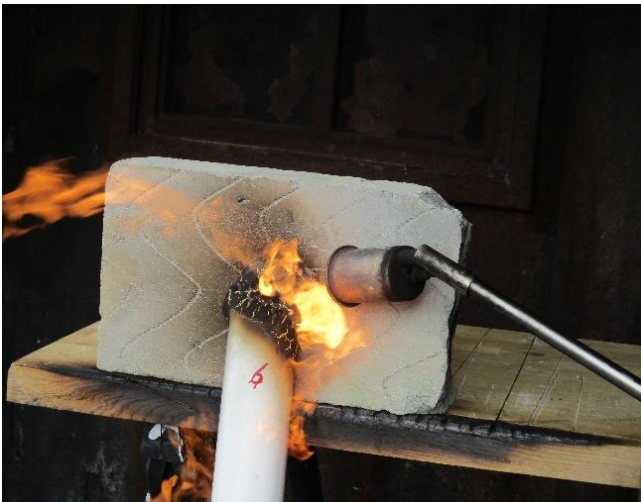
## 'Pink foam' and collars in a series of ad-hoc tests, conducted by the Fire Safety Team

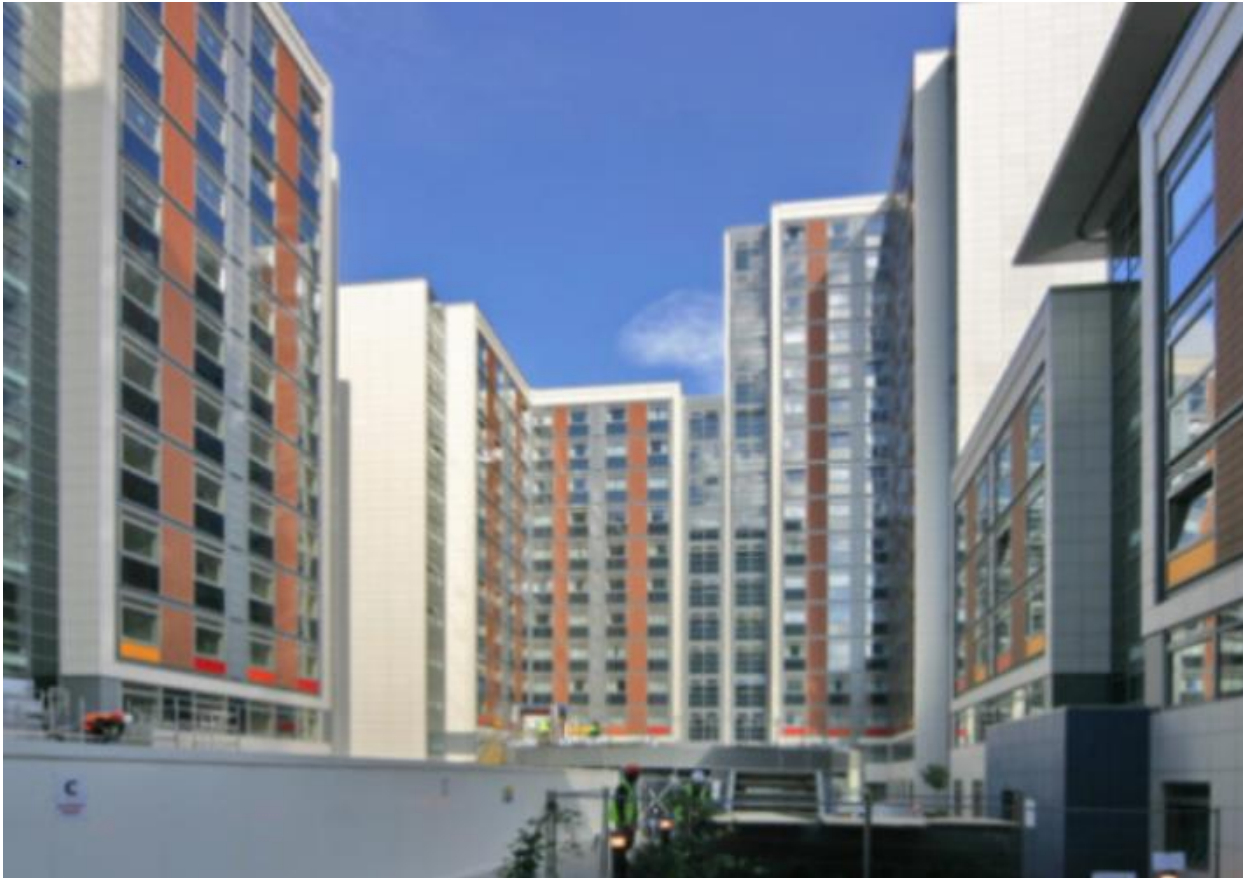
Paragon Student scheme near Brentford completed in 2007 now needs £8m worth of retrofit work  
The development near Brentford came under scrutiny after the Grenfell Tower disaster

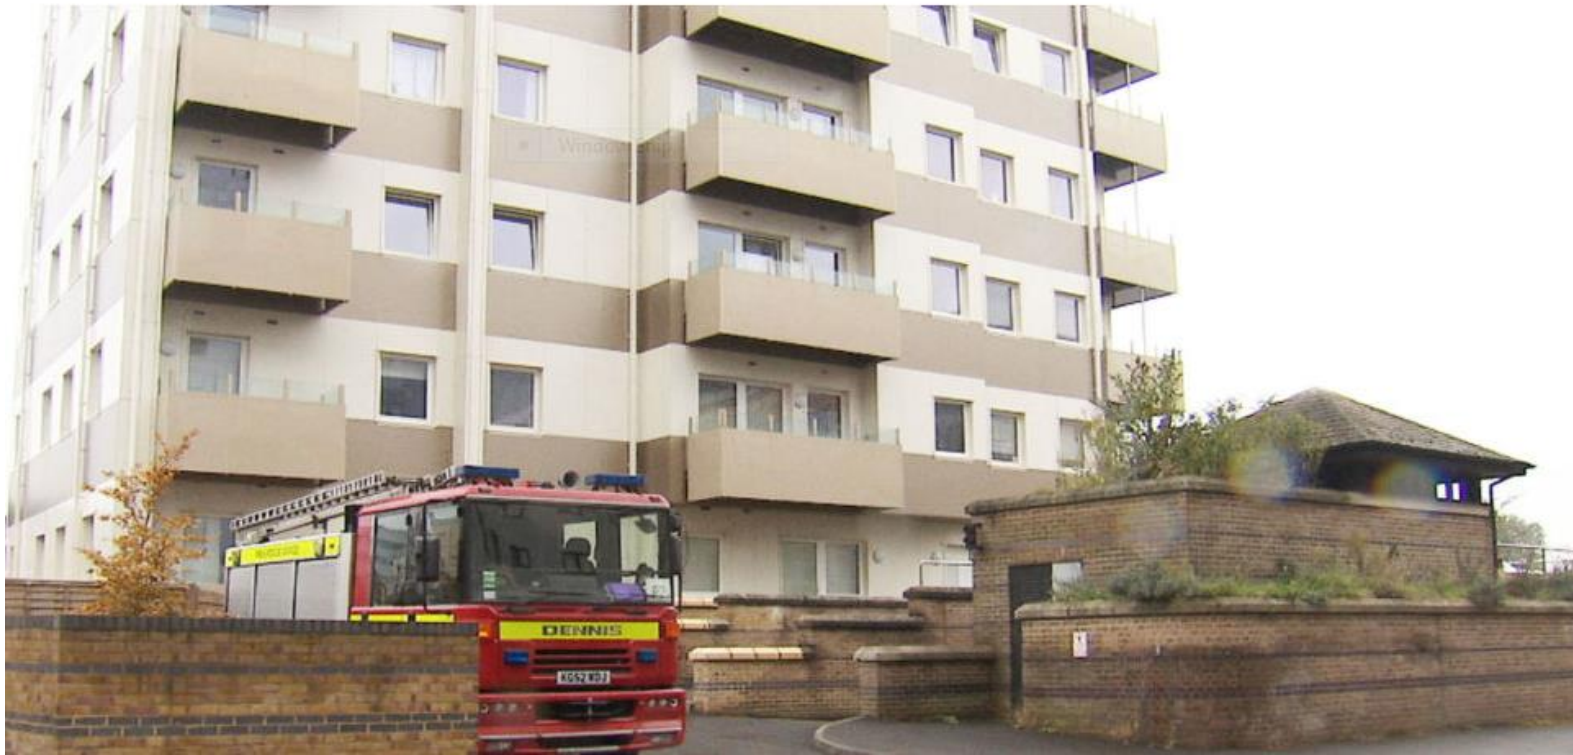
A fire engine and crew are being paid to park outside the privately owned Nova House in Slough, Berkshire, after fire brigade and council inspections revealed multiple fire safety failings.
